INDOOR AIR QUALITY ASSESSMENT

**Leominster City Hall
25 Water Street
Leominster, Massachusetts**

Prepared by:
Massachusetts Department of Public Health
Center for Environmental Health
Emergency Response/Indoor Air Quality Program
October 2006

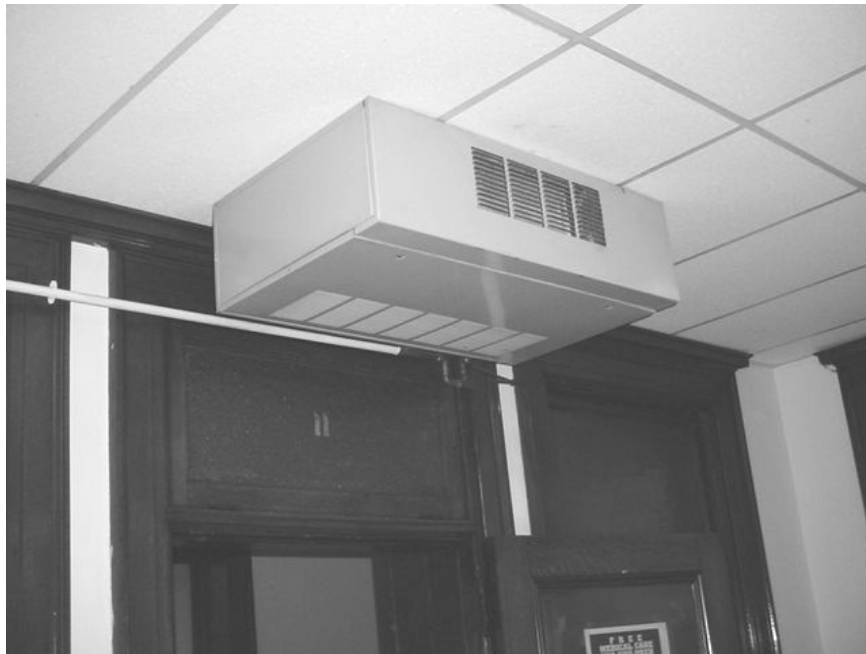
Picture 1

Mechanical ventilation in office space is provided by ceiling or floor-mounted fan coil units (FCUs) (Picture 1). However, the FCUs do not draw fresh air from outdoors through an air intake, rather they recirculate existing air. The sole source of fresh air is via opening windows. The use of the windows in basement office at the front of the building is limited due to reports of vehicle exhaust from traffic near the building. During the visit, FCUs were found deactivated throughout the building. The operation of FCUs will aid in air movement, which may increase comfort in basement offices.

FCU

1. Ensure FCUs are activated during business hours year round. This will help to increase air circulation, particularly in the Health Department offices.

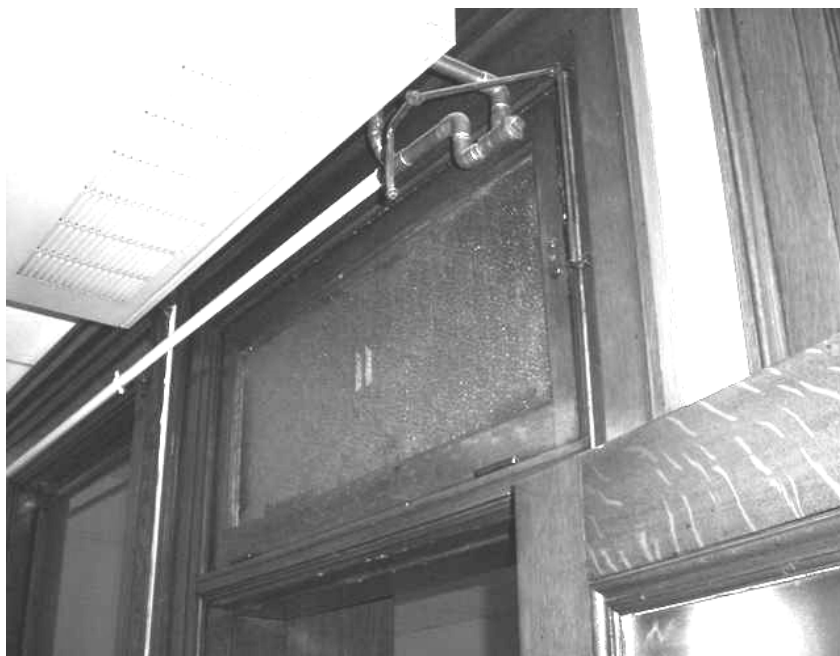
Picture 2

The building was originally designed to use openable windows to create cross-ventilation to provide comfort for building occupants using windows on opposing exterior walls. In addition, the building has hinged windows located above the hallway doors. The hinged window (called a transom) (Picture 2) enables occupants to close hallway doors while maintaining a pathway for airflow into the room. This design allows for airflow to enter an open window, pass through a room, pass through the open transom, enter the hallway, pass through the opposing open room transom, into the

Transom

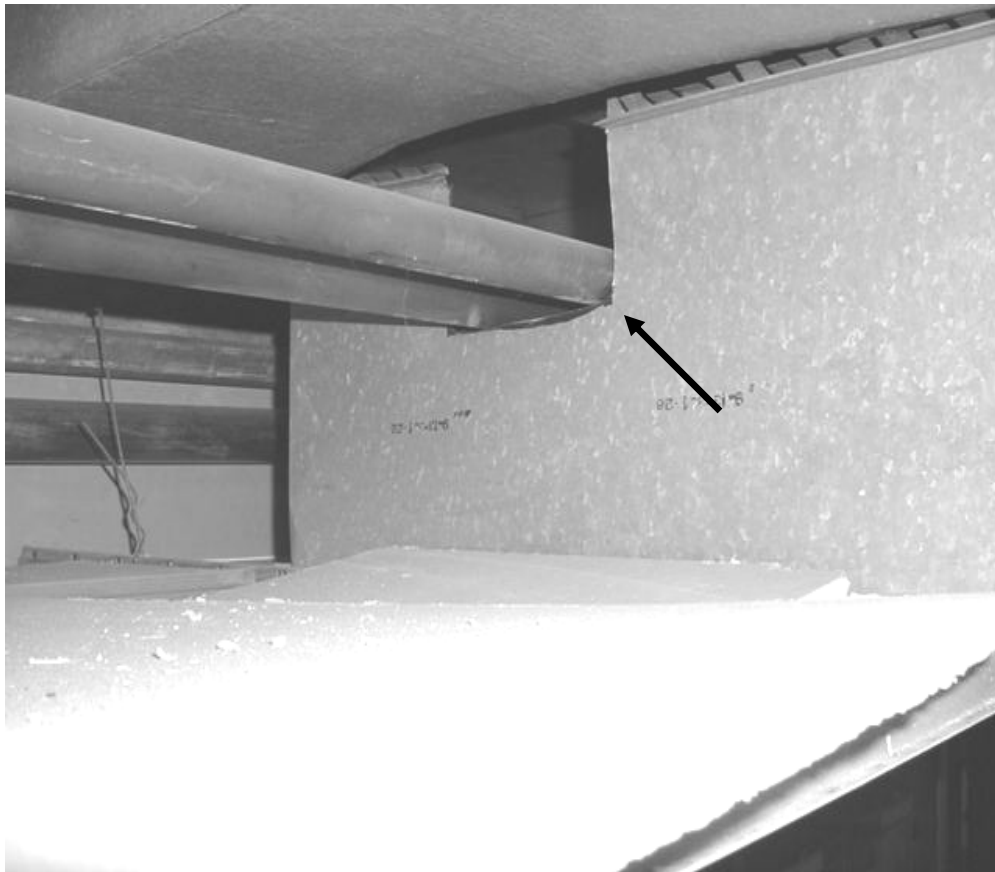
Picture 3

Large meeting areas are equipped with ceiling or wall mounted fresh air diffusers and return vents connected to air handling units (AHUs) with fresh air intakes and exhausts, located in the boiler room. Of note is the fresh air supply ductwork above the ceiling in the City Council Meeting room, which has a large breach, allowing air to escape and pressurize the ceiling plenum above the room (Picture 3). Airflow in the ceiling plenum would disturb dust and dirt and have the potential to migrate into the room through the ceiling system.

Ductwork above City Council Meeting Room, note hole

4. Use the heater in the elevator room during cold weather to prevent/limit condensation.
5. Seal the breach in the fresh air supply ductwork above the City Council Meeting Room.

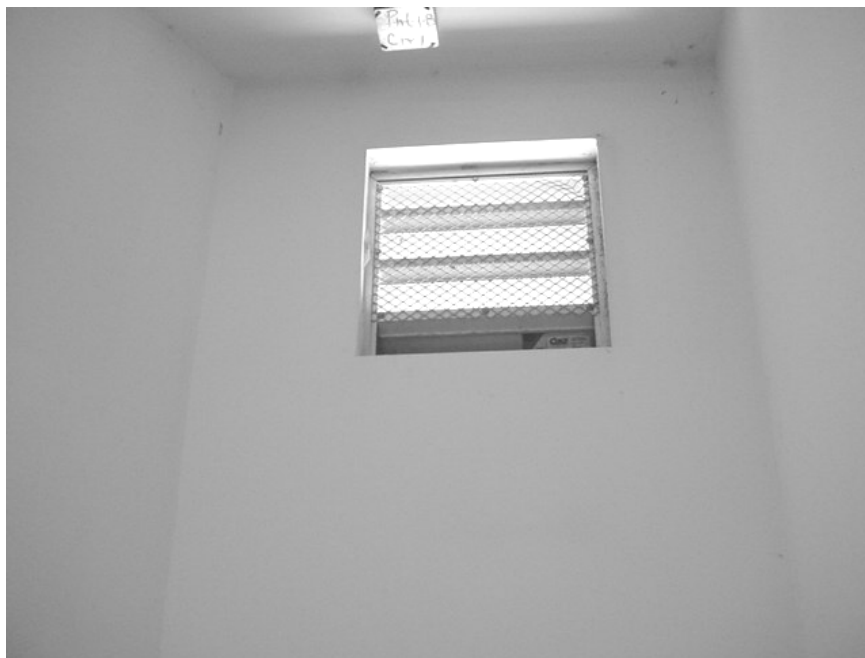
Picture 4

Building occupants reported odors from the elevator carpet. Sometime after the 1970s renovation, an elevator was added to the west wall of the LCH. A room containing the elevator motor was constructed on the basement level, with a passive vent installed in the exterior wall of the building (Picture 4). A corresponding vent exists in the elevator shaft wall (Picture 5). The purpose of these vents is to equalize air pressure in the elevator shaft as the car moves. Since this room is open to the outdoors, the room and elevator shaft likely becomes extremely cold in the winter, as confirmed by employees in the office that contains the elevator room entrance. Cold air would then be drawn into the elevator shaft. Under these circumstances the elevator car floor can be prone to condensation.

Elevator pressure equalization vent, exterior wall

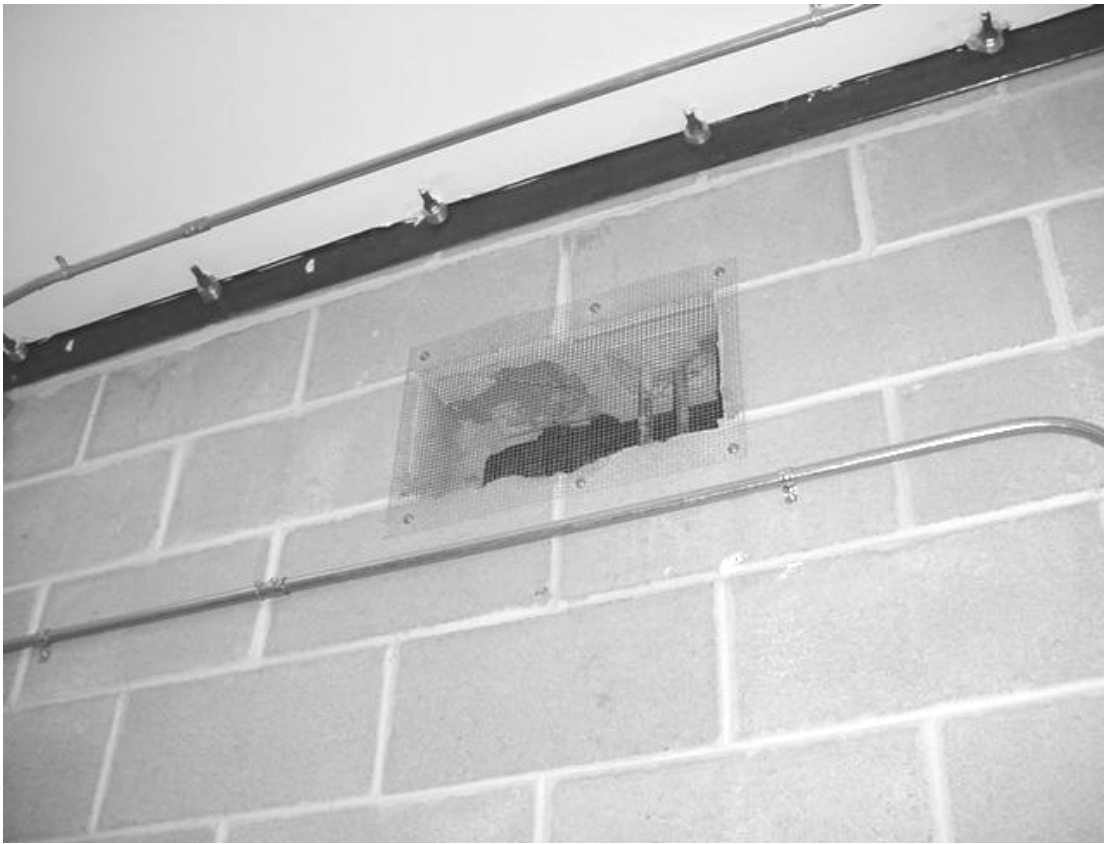
Picture 5

Elevator pressure equalization vent, elevator shaft wall

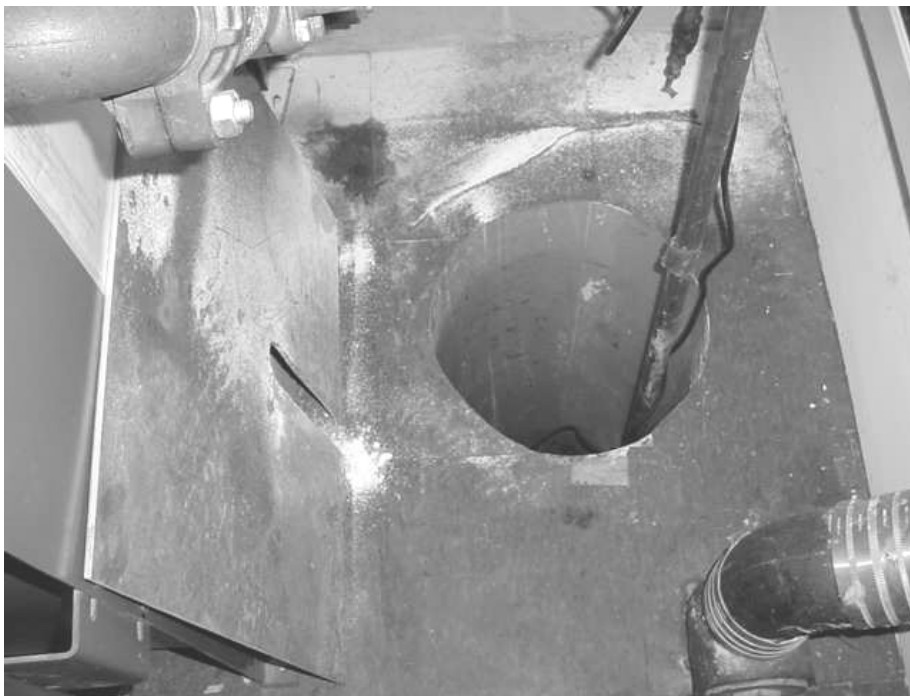
Picture 6

It appears that the designer of the elevator system was concerned with the possibility of cold air affecting the elevator motor and condensation, since an electric baseboard heater was installed in the elevator room. The heater should be activated during cold weather to heat the room and decrease condensation. In addition, a sump pump exists in the floor of the elevator room (Picture 6). The cover for the pump was off, exposing the sump pump which had standing water in it. The cover should be replaced to minimize the drawing of odors into the elevator/shaft.

Sump pump, note cover on floor

2. Remove carpet from elevator floor. Replace with a non-porous material (e.g., tile) to limit possible mold growth.
3. Replace cover on sump pump in elevator room. Install a hose in the cover to draw air from outdoors when the pump operates. Render the sump pump cover airtight with a sealant compound.

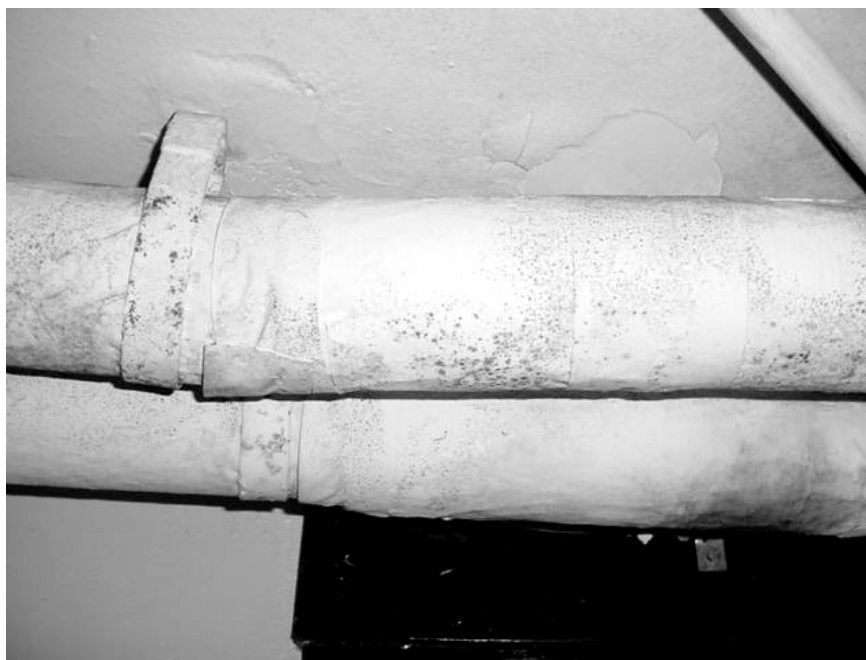
Picture 7

A restroom in the basement had mold colonized pipe insulation (Picture 7). This condition may indicate that the restroom does not have adequate exhaust ventilation to remove water vapor. Another restroom in the basement had a disconnected flexible duct, allowing for restroom odors and water vapor to vent into the ceiling plenum (Picture 8). Restroom vents should vent directly outdoors.

Mold colonized pipe insulation

6. Ensure that all FCUs have filters of sufficient size.
7. Service FCUs on a regular basis. This includes changing filters and cleaning drip pans.
8. Replace mold colonized pipe insulation in basement restroom. This material should be examined by a licensed asbestos inspector to ensure that remediation does not create an asbestos hazard.

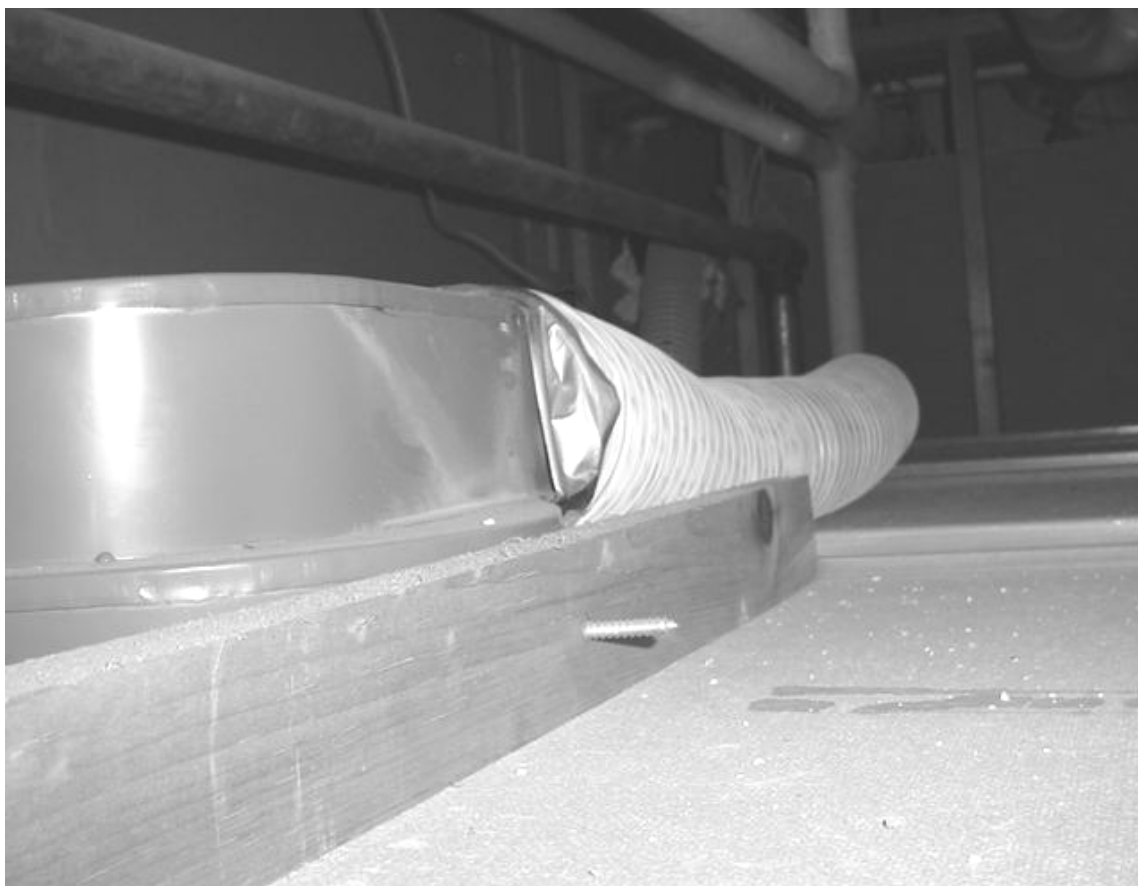
Picture 8

Hose detached from rest room fan

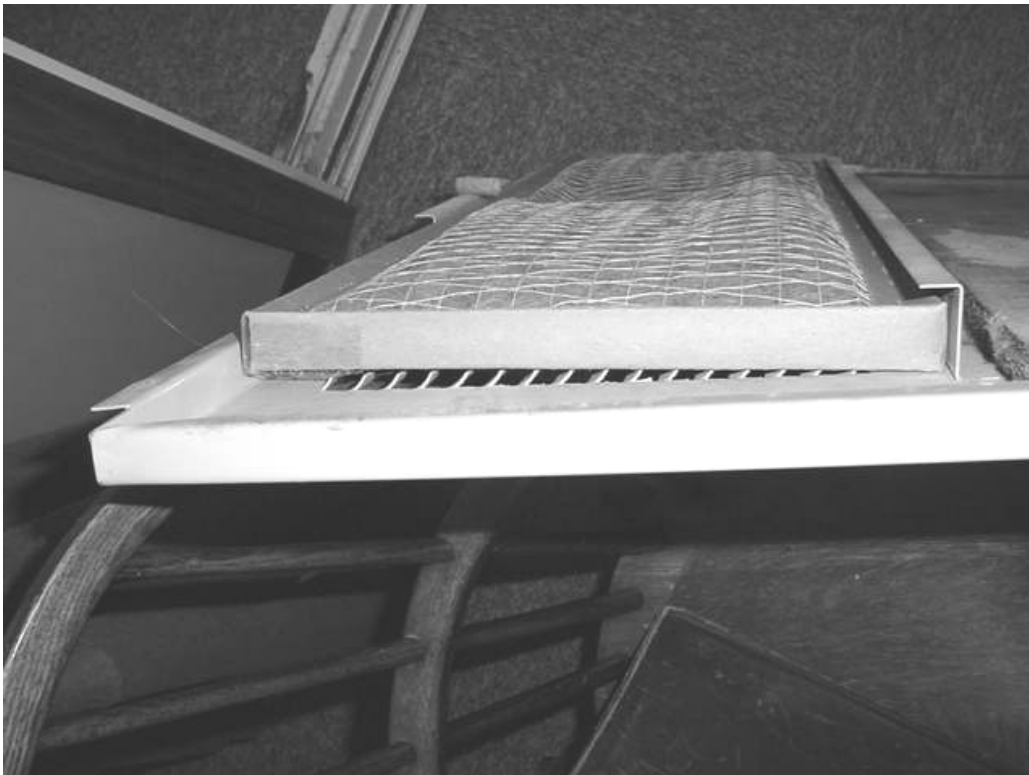
Picture 9

FCUs are normally equipped with filters that strain particulates from airflow. Filters found inside the FCUs were not of sufficient size (Picture 9). With smaller filters, particulates/debris can be drawn into and accumulate inside the FCUs. Accumulated debris inside the FCU can obstruct airflow and may serve as a reservoir of particulates that can be re-aerosolized and distributed to occupied areas. In order to decrease aerosolized particulates, properly-sized, disposable filters with an adequate dust spot

Undersized filter in FCU

efficiency should be installed. The dust spot efficiency is the ability of a filter to remove particulates of a certain diameter from air passing through the filter. Filters that have been determined by ASHRAE to meet its standard for a dust spot efficiency of a minimum of 40 percent would be sufficient to reduce airborne particulates (Thornburg, 2000; MEHRC, 1997; ASHRAE, 1992). Note that increasing filtration can reduce airflow, a condition known as pressure drop, which can reduce efficiency due to increased resistance. Prior to any increase of filtration, a ventilation engineer should be consulted as to whether the FCUs can maintain function with more efficient filters.
